# Memorandum

**RE:** DSS-13 Azimuth Wheel Fatigue Analysis

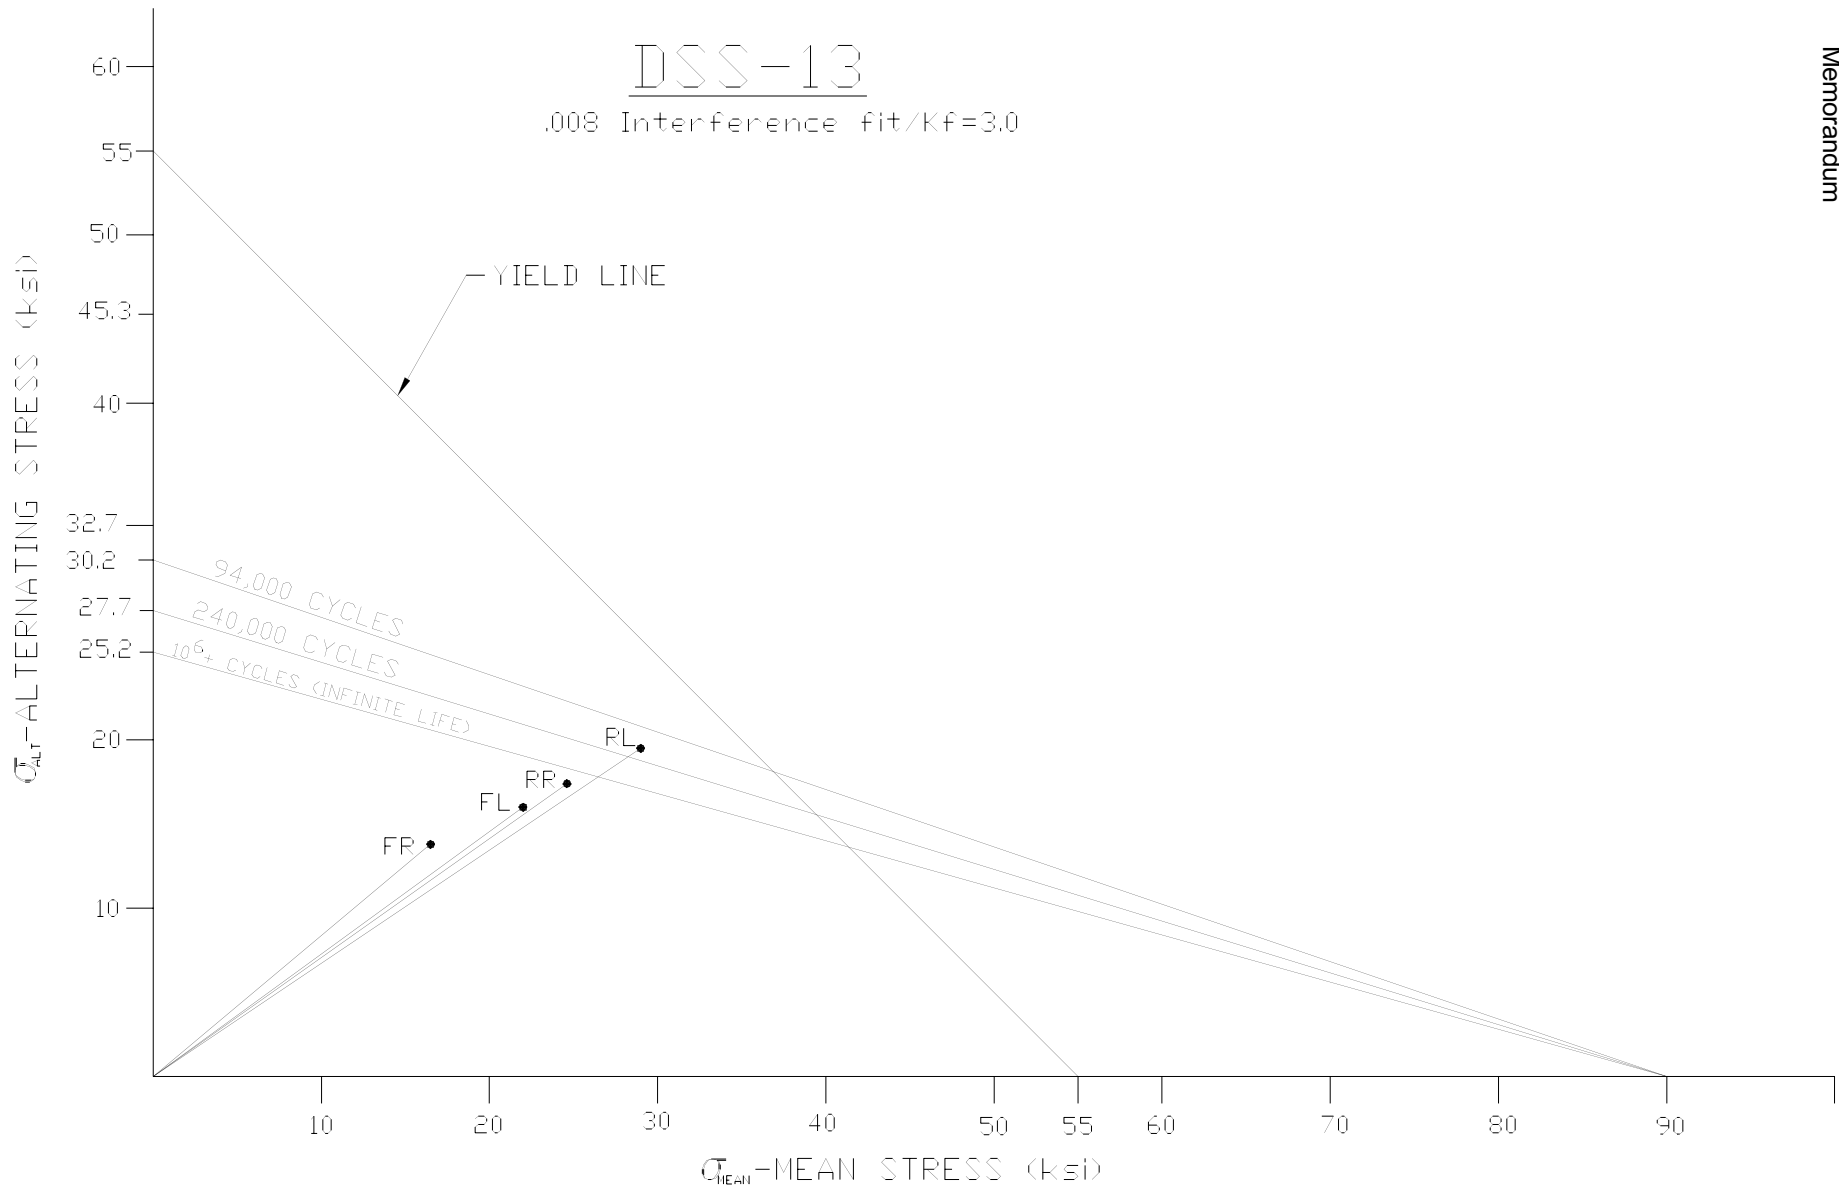
CONSTANT LIFE FATIGUE DIAGRAM  
1045 STEEL - 90ksi UT/55ksi YS

From the fatigue graph (see attached) we can see that three of the wheels are in the 'infinite life' region. The Fourth wheel (Rear Left) because of the increased load falls outside of the infinite life region yet is still below the estimated cycle life of the antenna. Based on the fatigue graph and the low duty cycle of DSS-13, there does not appear to be an immediate need for concern. The two wheels of greatest concern are the idler wheels, this makes an ultrasonic inspection of the axles a relatively easy process. It is my recommendation that an ultrasonic inspection of the idler axles be performed as soon as possible. If no indications of a crack are found, a yearly ultrasonic axle inspection should be incorporated into the maintenance program.
